LOWER LISBON DAM  
N.H. 00144

PHASE I INSPECTION REPORT  
NATIONAL DAM INSPECTION PROGRAM

APRIL 1979

Identification No: NH 00144  
Name of Dam: Lower Lisbon Dam  
Town: Lisbon  
County and State: Grafton County, New Hampshire  
Stream: Ammonoosuc River  
Date of Inspection: November 15, 1978

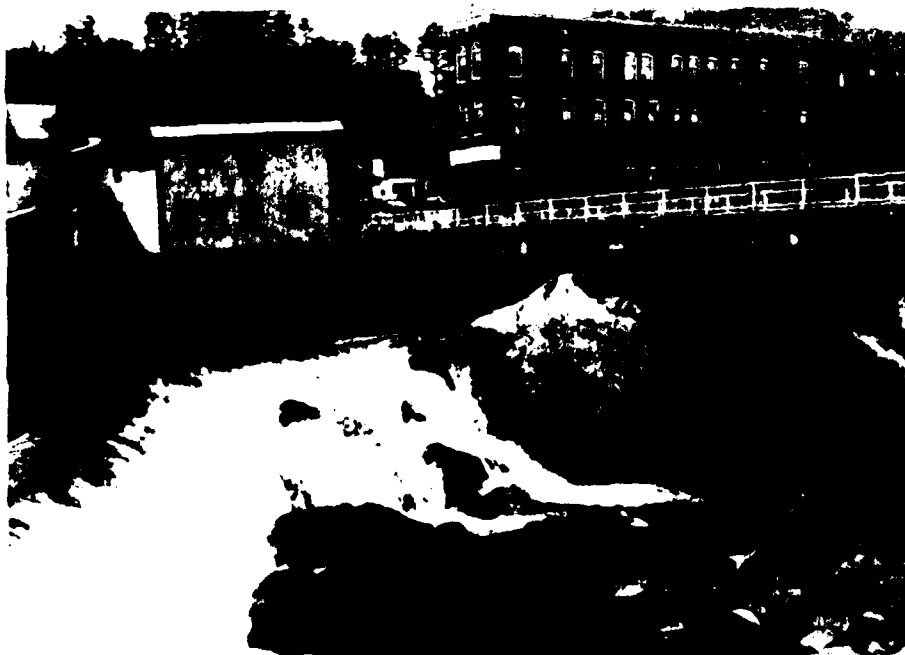
The maximum known flood on the pertinent section of the Ammonoosuc River occurred on March 18, 1936, recorded at the Bath gauge as 27,900 CFS. Transferring this flow to the dam using the six tenths ratio of their drainage areas gives a flood of 23,080 CFS at Lower Lisbon Dam. This flow would result in a flow depth of 8.3 feet over the spillway. Although this flood stage would not overtop the dam abutments it would cause considerable flooding along the left bank which is considerably lower than the dam abutment (see Photo 2).

#2. VIEW OF SPILLWAY

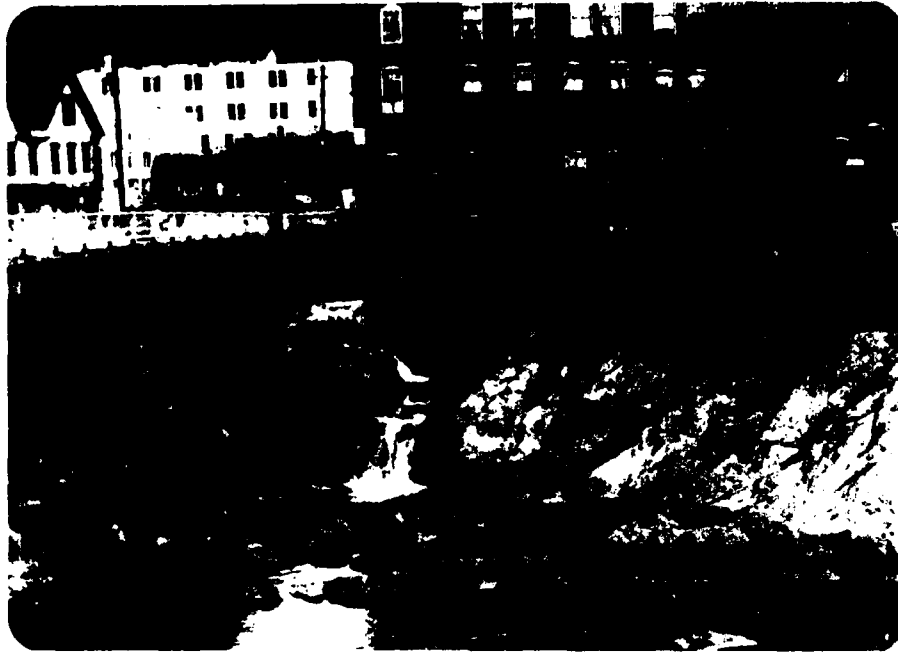
The next section of the dam connects the outcrop mentioned above to another outcrop adjacent to the waste gate. This is a raised berm section approximately 34 feet long with a 6-foot stop log spillway located 7 feet from the left outcrop (see Photo 3). This section is in good condition with some spalled areas.

#3. VIEW OF WASTE GATE AND FORMER HEADRACE CANAL
